HUBBARD DRIVE REPAIRS TOWN HALL MEETING

SEPTEMBER 1, 2022

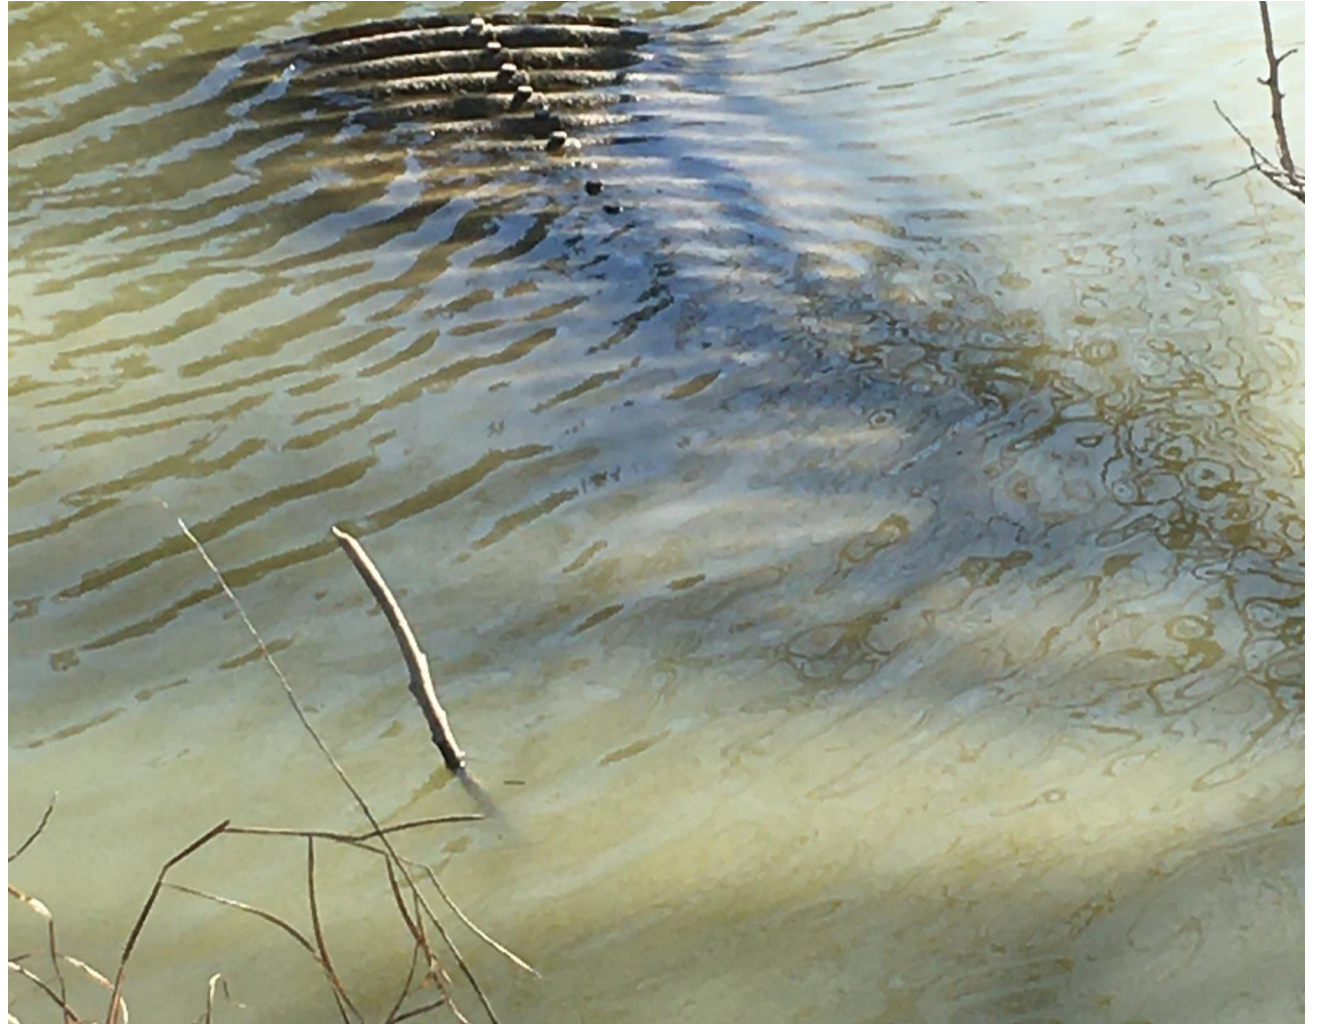
CONDITION OF METAL CULVERT

- IN JANUARY OF 2022, AS THE LAKE LOWERED, THE END OF THE CULVERT SURFACED SHOWING THE PIPE HAD BEEN BROKEN AND BENT UPWARD THE PREVIOUS YEAR.
- IT IS BELIEVED THE TOP OF THE PIPE HAS CORRODED OVER IT'S 50+ YEARS IN USE AND ALLOWED THE FILL ON TOP TO CAVE IN.

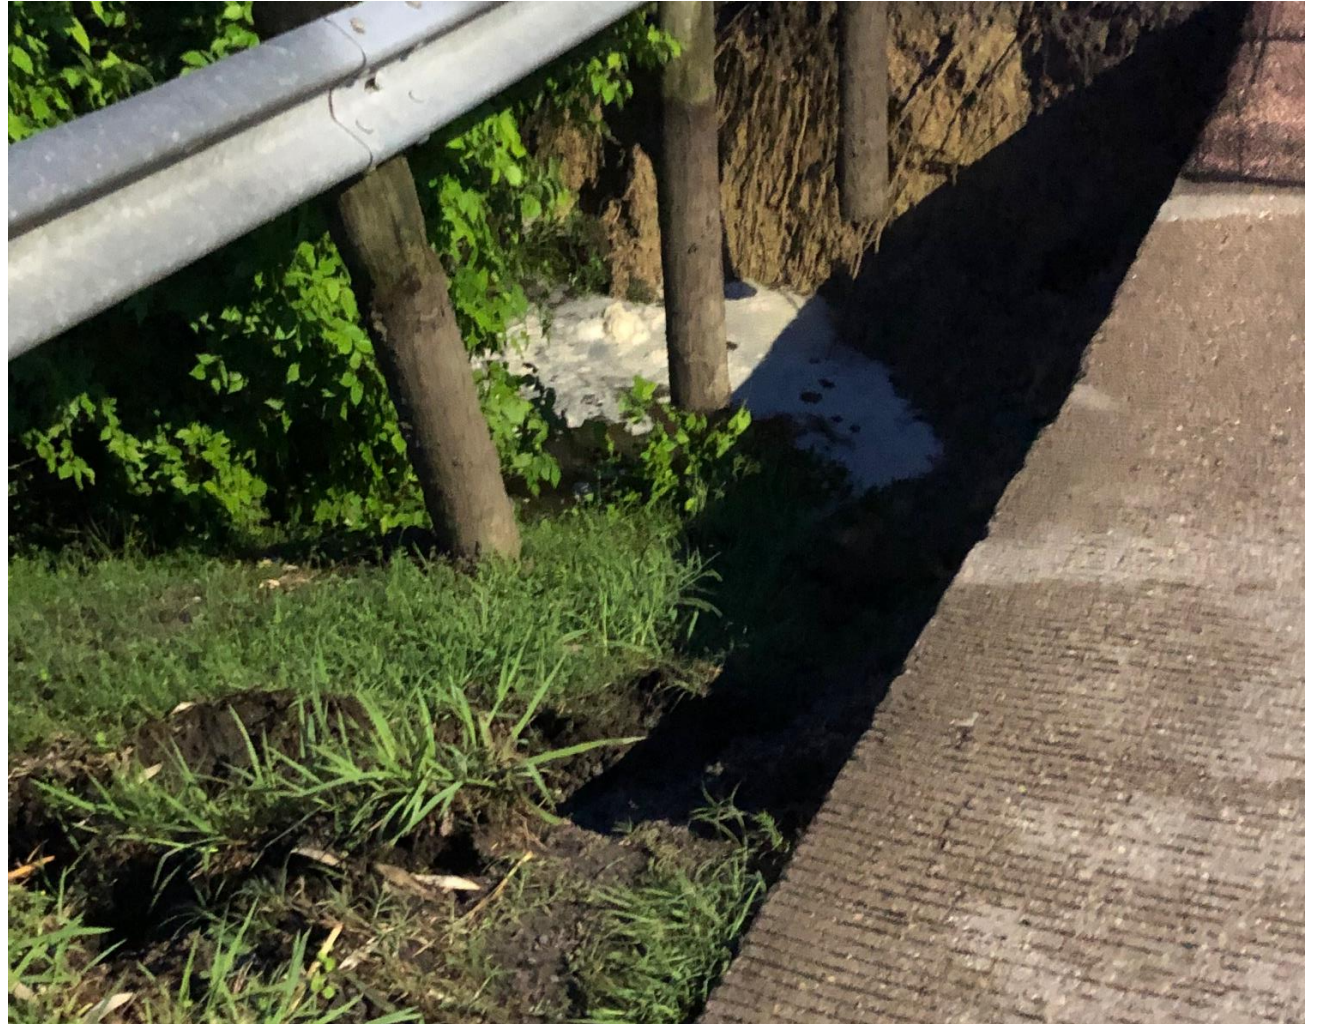
RESULT OF EROSION ON DAY OF CULVERT FAILURE

- IN MAY OF 2021, THE 50+ YEAR OLD METAL CULVERT IN HUBBARD DRIVE FAILED ON THE SOUTH EDGE OF THE PAVEMENT.
- EMERGENCY REPAIRS WERE MADE THE DAY OF THE FAILURE TO STABILIZE THE EMBANKMENT AND TO GIVE TIME TO EVALUATE THE SITUATION.
- THE ROAD WAS REOPENED TO ONE LANE AT THE WASHOUT FOR SEVERAL MONTHS.
- AFTER OBSERVING THE REPAIRS FOR SEVERAL MONTHS, IT APPEARED THE EMBANKMENT REPAIRS AND CULVERT WERE STABLE AND THE LAKE WATER LEVEL WAS THE SAME AS THE WATER LEVEL ON THE RUSH CREEK SIDE. HOWEVER, IT WAS CLEAR THAT THE CULVERT WAS DAMAGED.

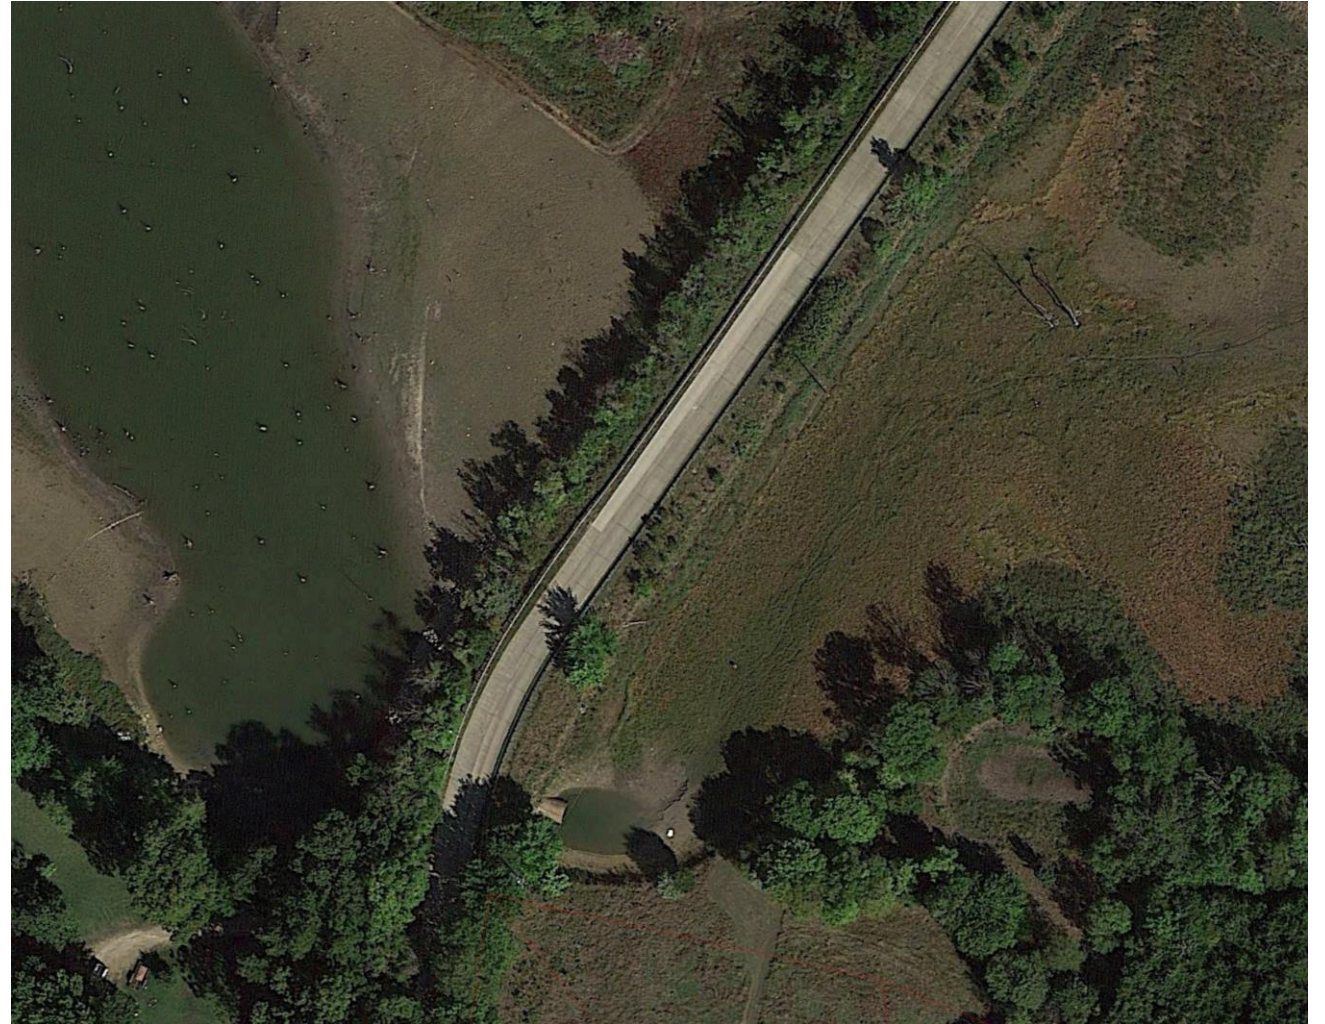
- THIS IS AN AERIAL PHOTO FROM 2013 SHOWING THE CULVERT THAT MEASURES ABOUT 8 FEET ACROSS.
- THIS IS THE ONLY LOCATION FOR WATER TO CROSS FROM RUSH CREEK TO THE LAKE.

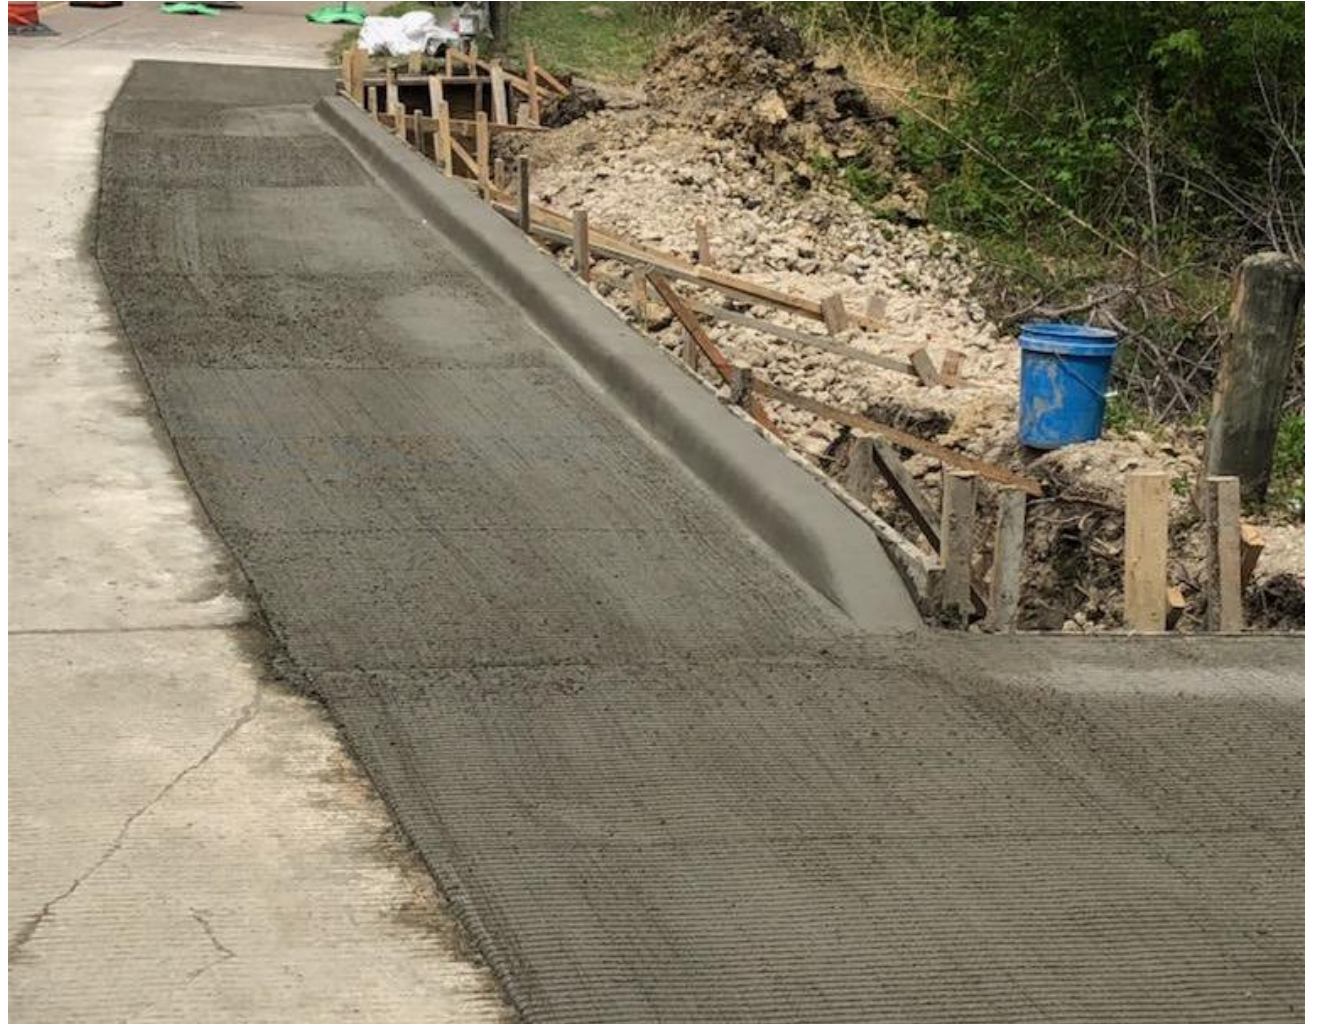
REPAIRS TO HUBBARD WASHOUT

- REPAIRS WERE MADE IN MARCH AND APRIL OF 2022 TO BRIDGE ACROSS THE FAILED CULVERT AREA.

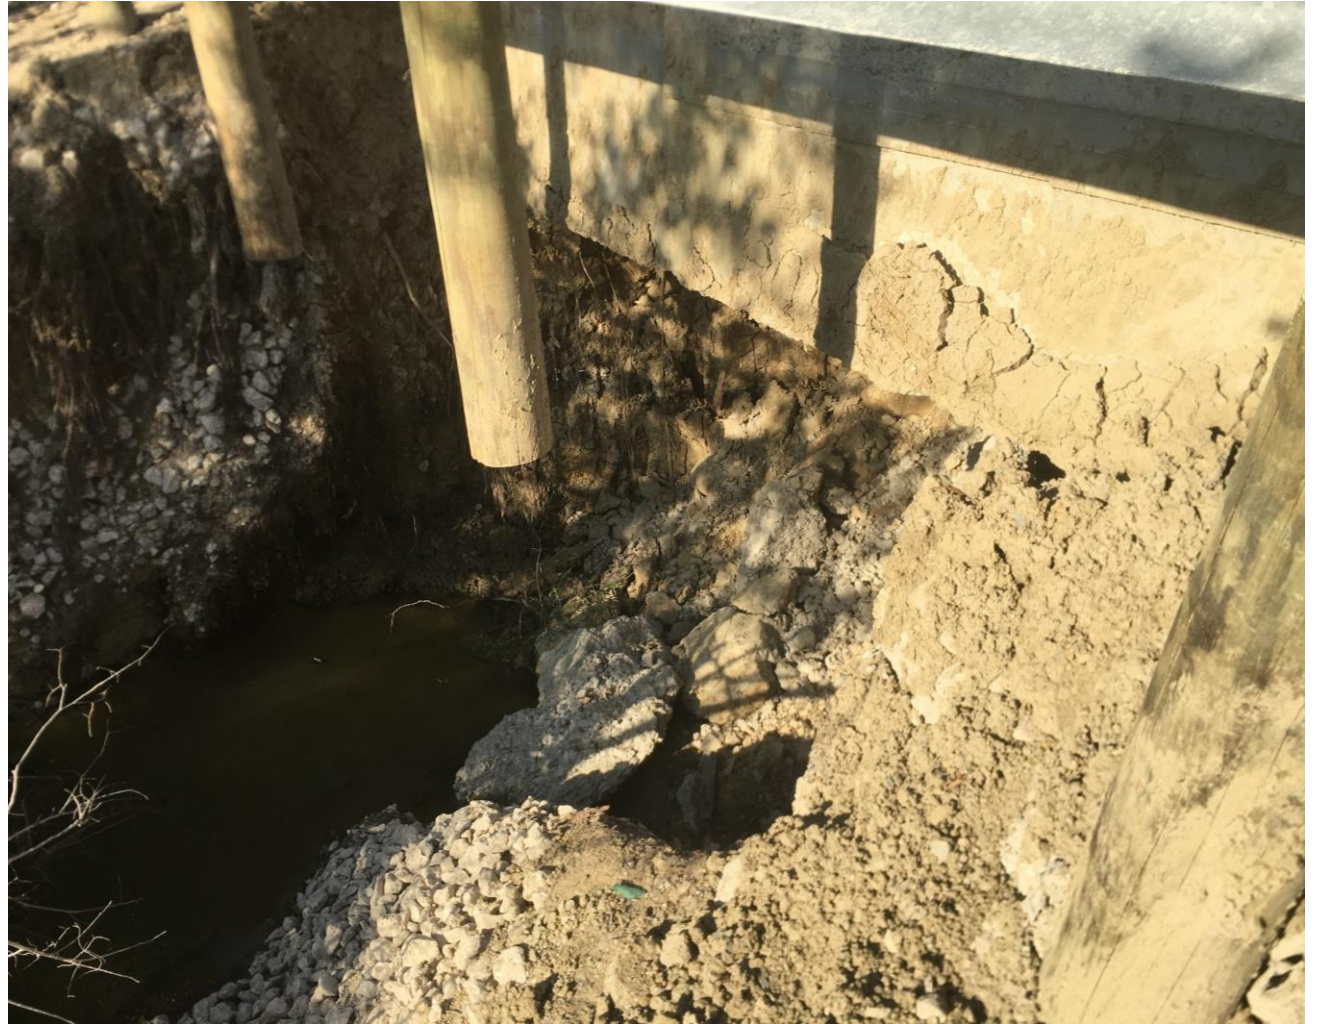
AUGUST 2022 EMBANKMENT FAILURE

- THE HEAVY RAINS FILLED THE LAKE AND WATER RAN BACKWARDS INTO THE COVE, ERODING THE BACKFILL UNDERNEATH THE OLD AND NEW PAVEMENT.
- THE REPAIRS MADE IN APRIL WERE NOT IMPACTED BUT THE STABILITY OF THE REMAINING PAVEMENT IS IN QUESTION.
- THE EROSION UNDER THE PAVEMENT WAS MEASURED TO BE 8 FEET UNDER THE CONCRETE.

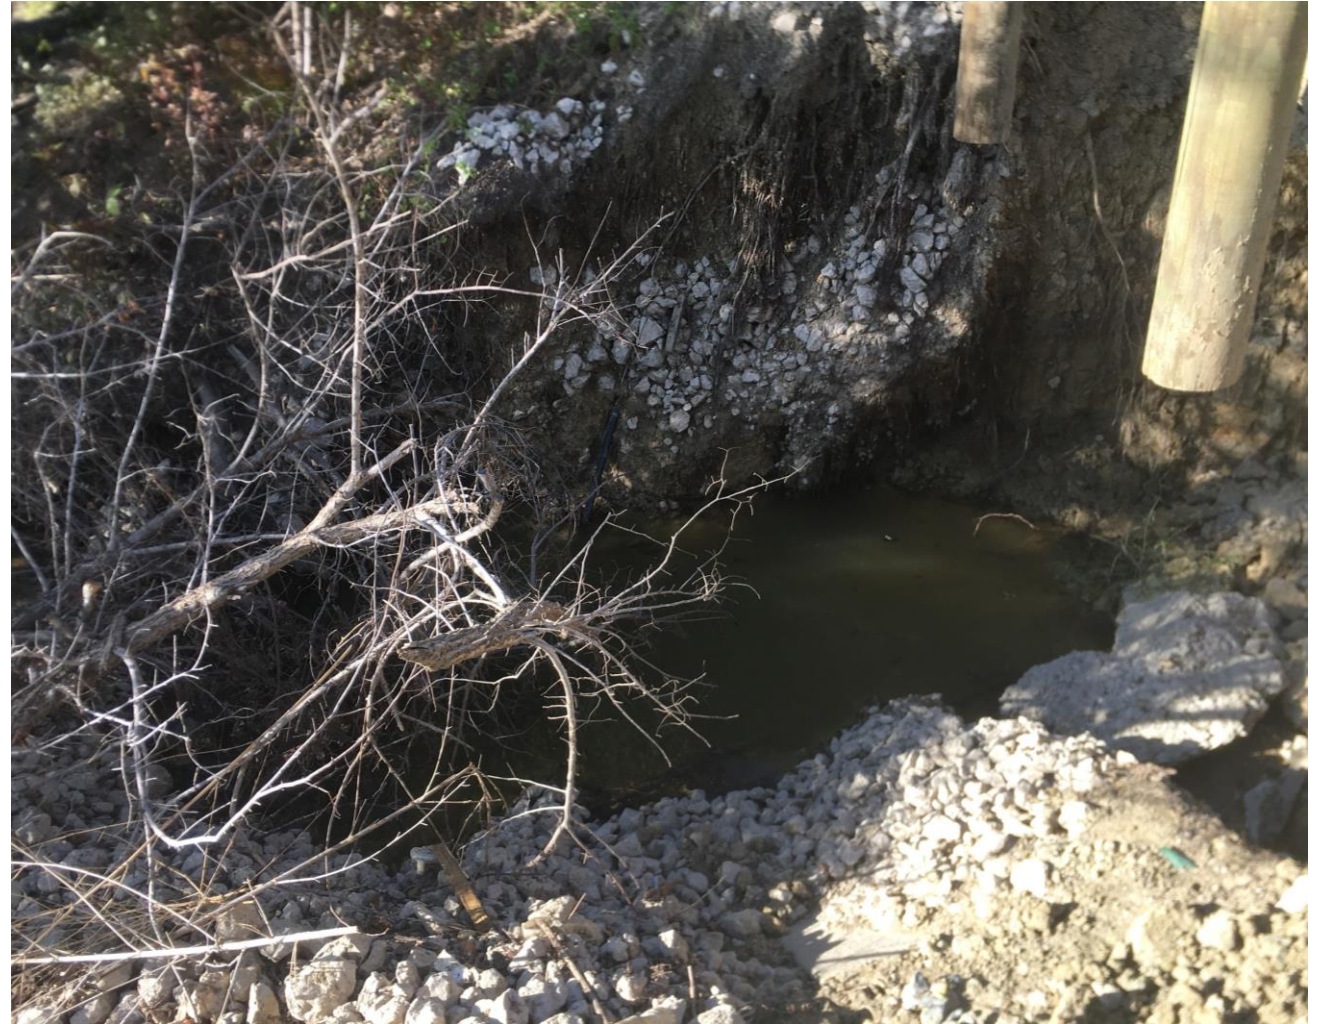
CONDITION OF CULVERT

- THE CULVERT IS FILLED WITH DEBRIS FROM THE WASHOUT.
- THE DEPTH OF THE WATER IN THIS PHOTO IS ONLY 2 FEET ON TOP OF THE DEBRIS.
- THERE DOES NOT APPEAR TO BE ANY CONNECTION OF THE WATER IN THE COVE AND THE LAKE AT THIS TIME.
- IF A LARGE RAIN OCCURS IN THE RUSH CREEK WATERSHED, IT IS POSSIBLE THE ROAD EMBANKMENT WILL NEED TO BE CUT TO ALLOW WATER TO CROSS TO THE LAKE.

- HEALTH AND SAFETY OF THE PUBLIC IS THE UTMOST IMPORTANCE.
- WE CANNOT GUARANTEE IF THE ROAD IS REOPENED, IT WILL NOT RESULT IN A CATASTROPHIC FAILURE.
- BECAUSE OF THESE TWO RESPONSIBILITIES TO THE PUBLIC, OUR RECOMMENDATION TO THE CITY COUNCIL WAS TO CLOSE THE ROAD AND COMPLETE THE RECONSTRUCTION AS SOON AS POSSIBLE.
